AW 55-50SN / AF 23-33

Diagnosis and Valve Body Information

Presented by
Bob Warnke
ATRA Powertrain Expo 2008

Adapting to the Aisin Warner 55 50SN valve body

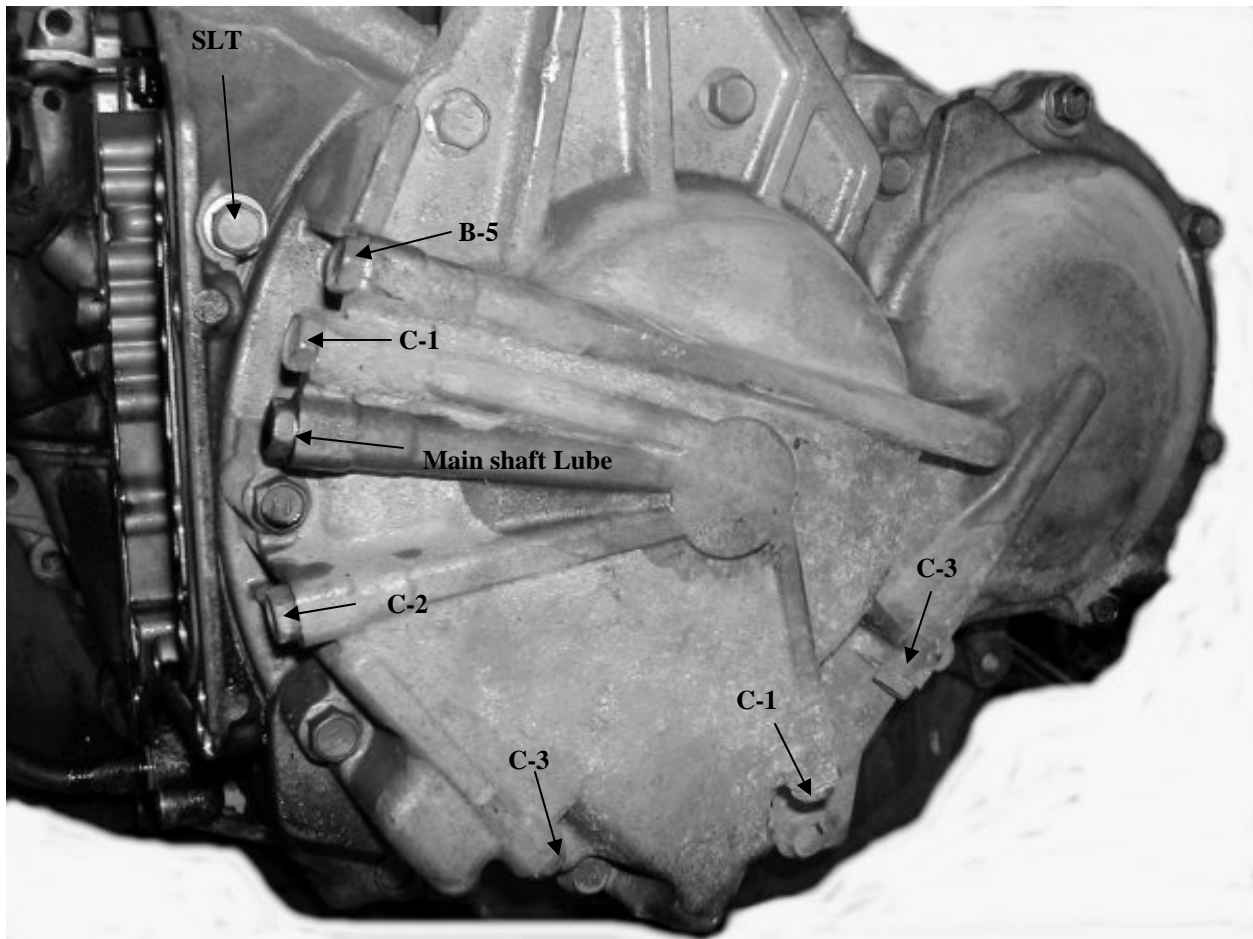
All the pressure plugs have a 12mm head. Do not mistake the 27mm band anchor (see Figures 1 and 2) for a fill plug or pressure tap. If that anchor is removed, the band will have to be recaptured. Positioning the band requires removal of the servo, at best and possibly the complete transmission.

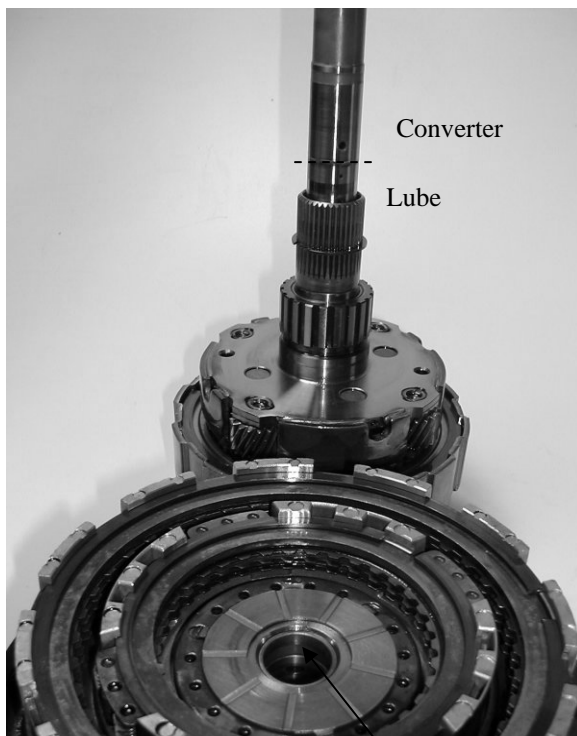
Critical pump stator bushing

Lube pressure and flow on the 55 50SN, is low in comparison to other units. This converter requires multiple valves, along with the rear pump bushing, to control modulated TCC apply (see Figure 3). The converter clutch may remain fully applied at very low speed and high load, which taxes the fluid and lining, creating a break-away slip or RPM fluctuation.

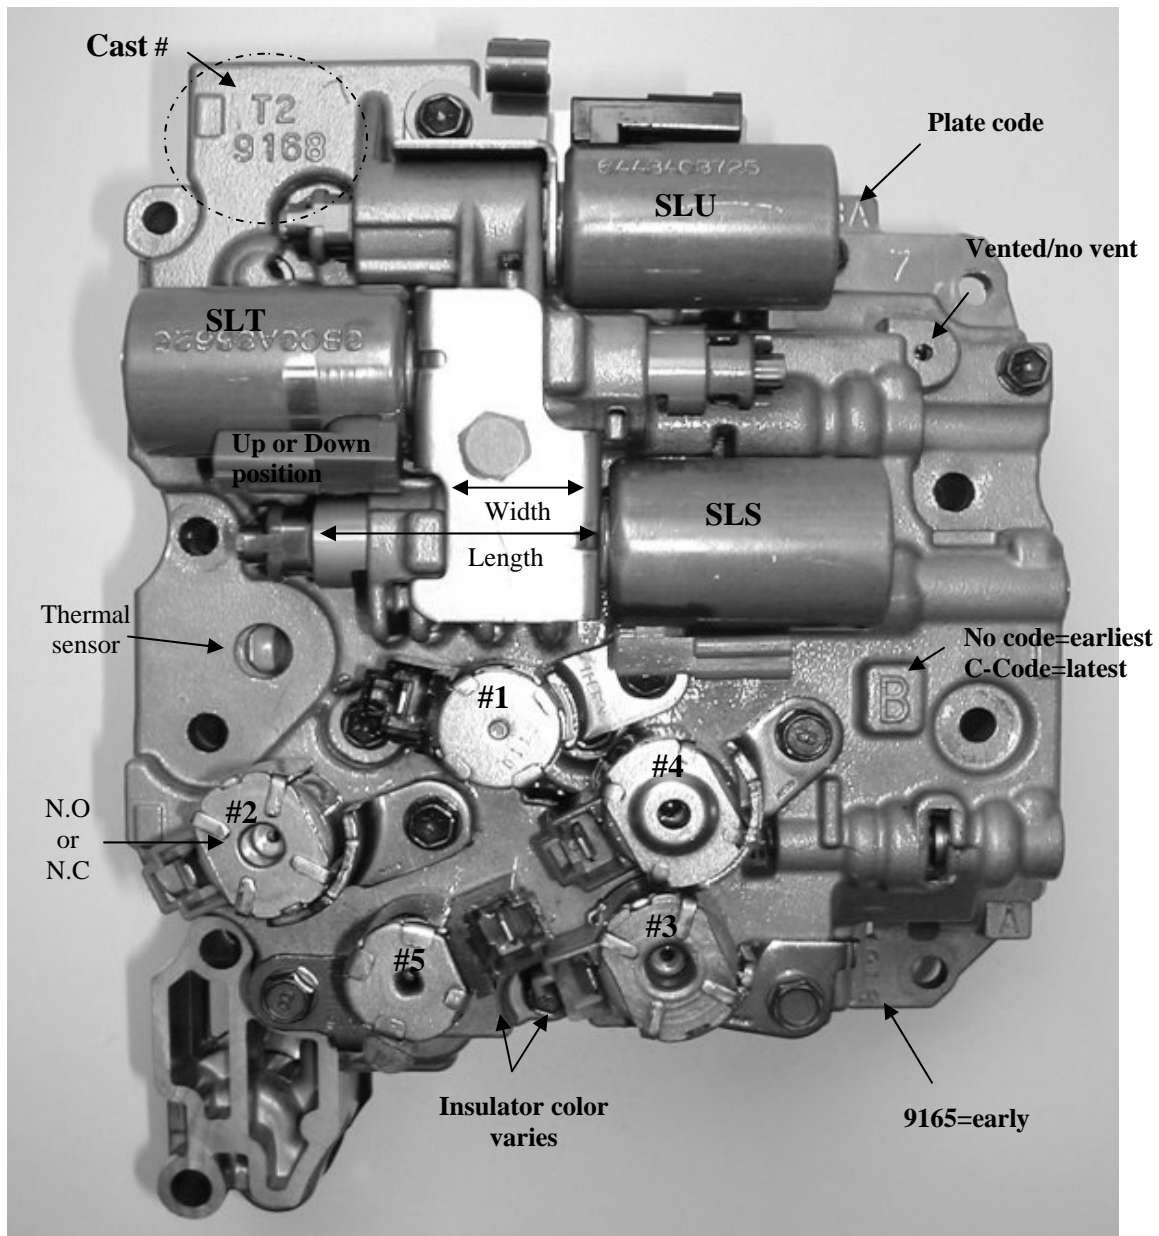
You can perform a similar air test (ill#4) with the valve body itself. When doing so, the pump line port and thermal element hole must be closed and the separator plate held as shown to eliminate cross leaks. This might sound confusing in print, but when you do it, the ports will be evident and easy to close with an opposite hand.

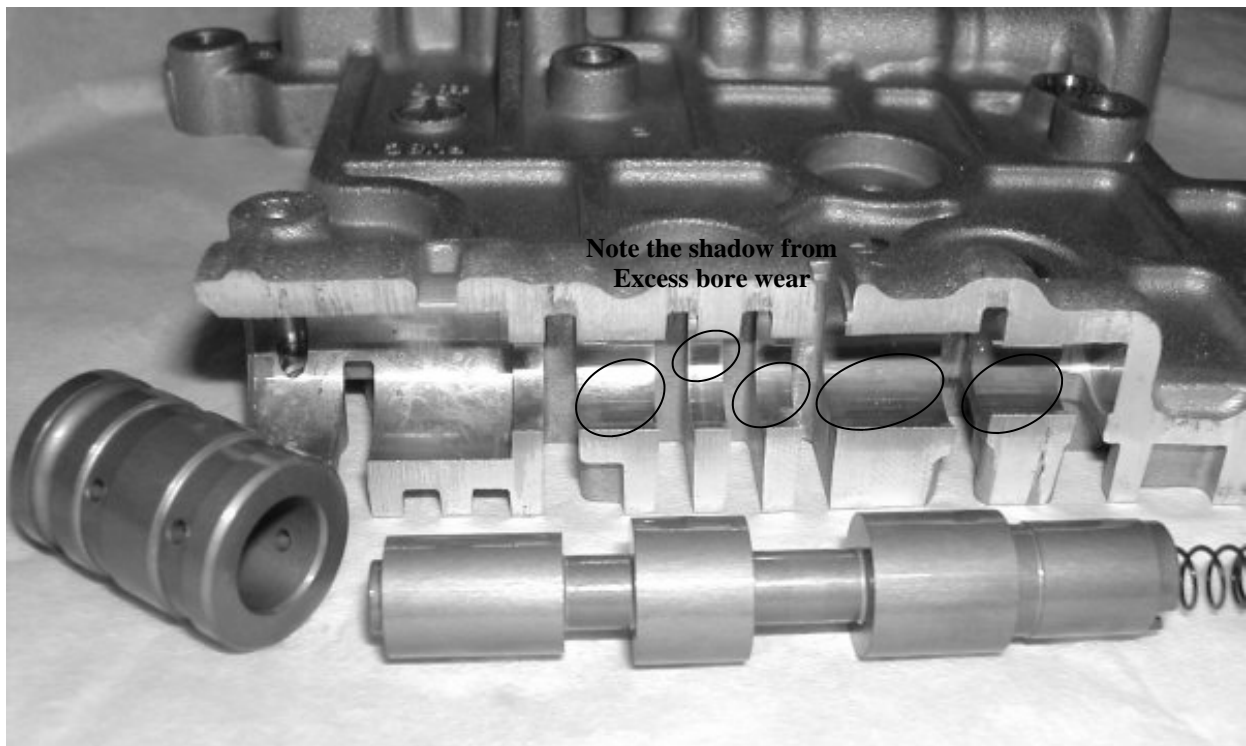
Excess wear appears as a discoloration, or polished area, in the shape of a moon phase, generally at the ends of the bore or opposite side of fluid entry (see Figure 6).

Three linear solenoids are calibrated to the valve body. Exchanging SLT, SLS solenoids between cores, without adjusting to the valves, is generally not acceptable. Don't hesitate to open and inspect the valve body...as it's comparable to other Asian Warner designs and not difficult to reassemble. That inspection should include all the removable sleeves, both regulator valves and the solenoid modulator bore. The linear solenoids are fed by this modulator valve which limits the maximum pressure. When that bore is worn, the concern is similar to a bad GM actuator feed circuit.

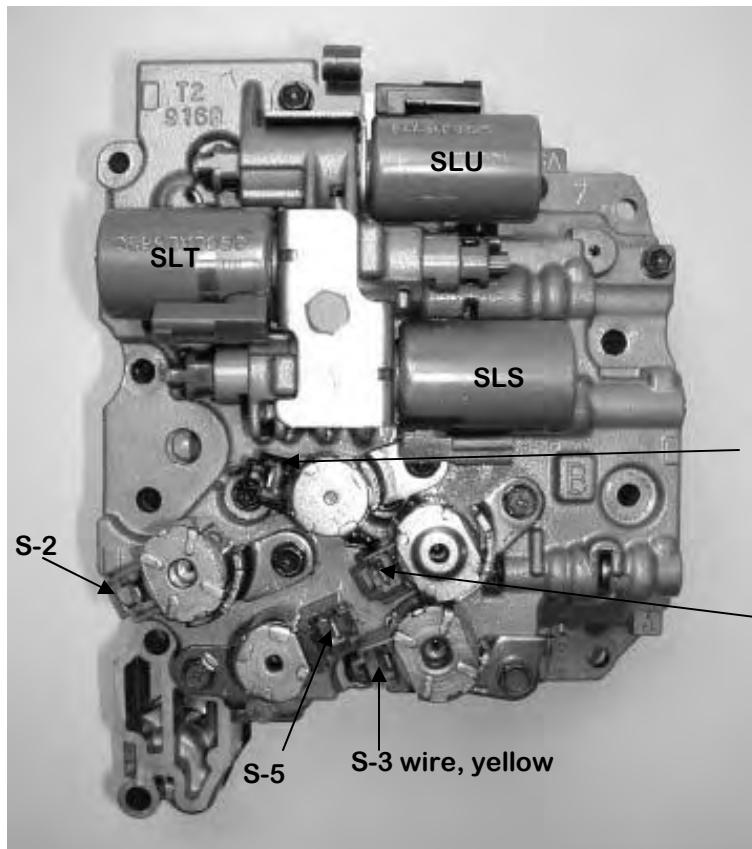
- Wiring Issues (see photo left)**
- Common to mix up connectors from harness
 - S1- White wire, right side loom.
 - S3- Yellow wire, left side loom.

S-1 wire, white

S-4

S-3 wire, yellow

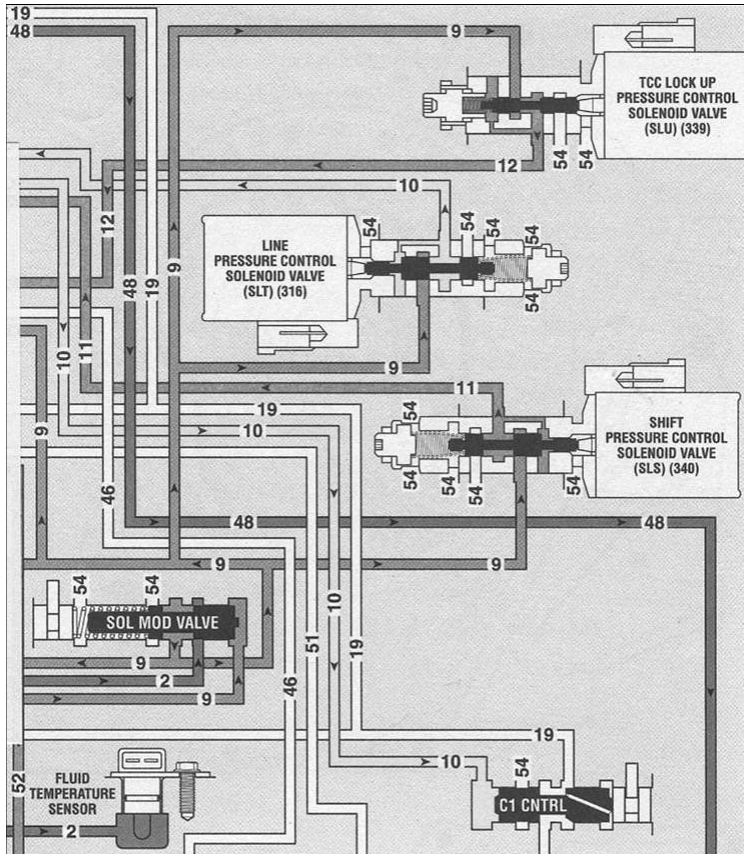
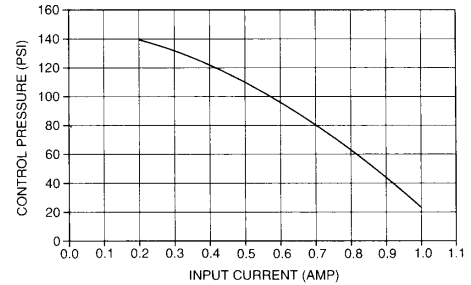
SL Solenoids

LINE PRESSURE CONTROL SOLENOID VALVE CURRENT FLOW

Note: This OE chart is referring to line pressure. Actual SL output is limited by solenoid modulator valve to 80 psi.

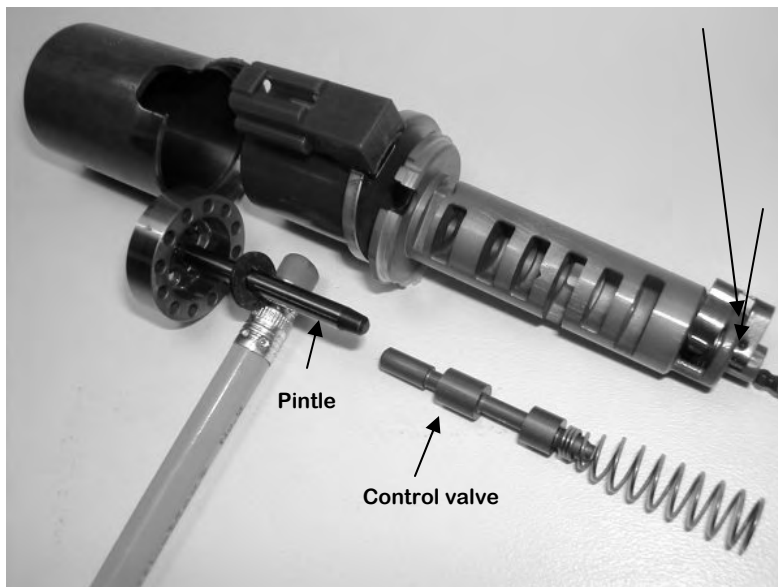
SLT-SLS

Measurement:
End of solenoid manifold to shoulder on adjuster

Preliminary adjustments:
.010"-.050", record prior to removal.

Measurement taken with retainer removed. Shoulder of adjuster to end of manifold.

Turning screw inward, raises SLT & SLS pressure
6 clicks = 1/2 turn.

Turning screw inward, reduces SLU
6 clicks = 1/2 turn.

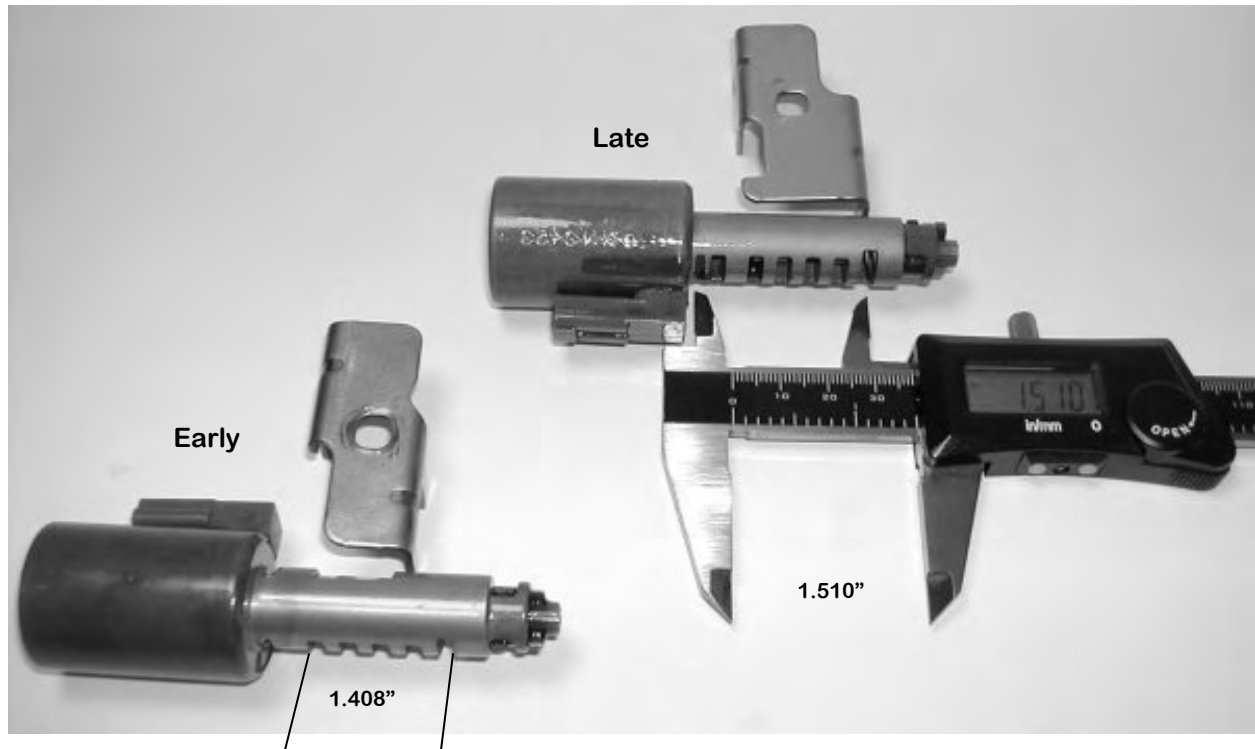
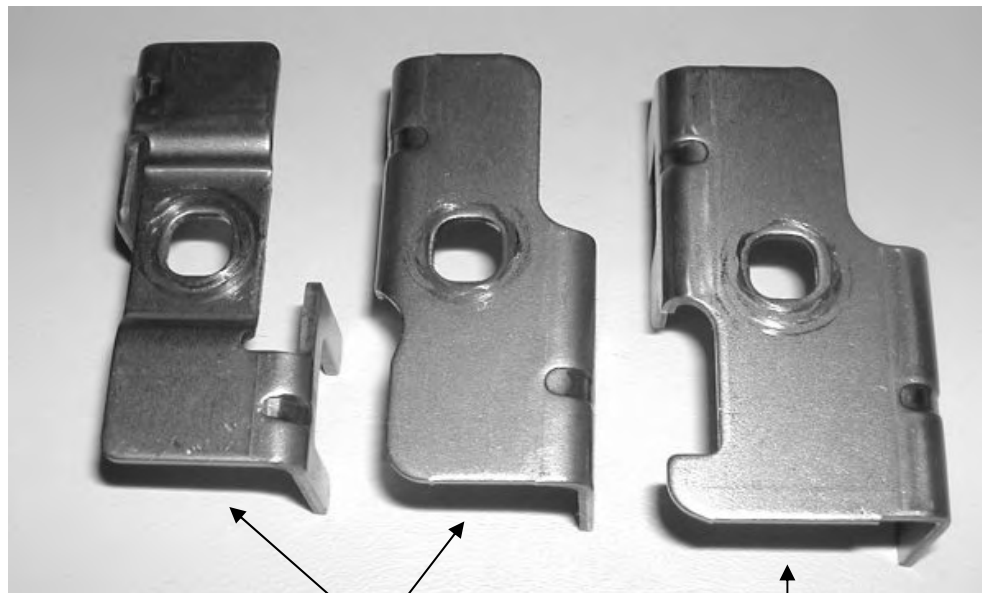
Early short brackets

Long late bracket

SLU-Remains same Early-Late

SLT-Early

- Slot for bracket results in solenoid connectors upward.
- Bracket is narrow type
- Distance bracket slot out ex. 1.408" (short manifold)

SLT-Late

- Slot for bracket results in connector down
- Wider bracket
- Long manifold 1.510"
- Connector down requires special harness, Volvo update.

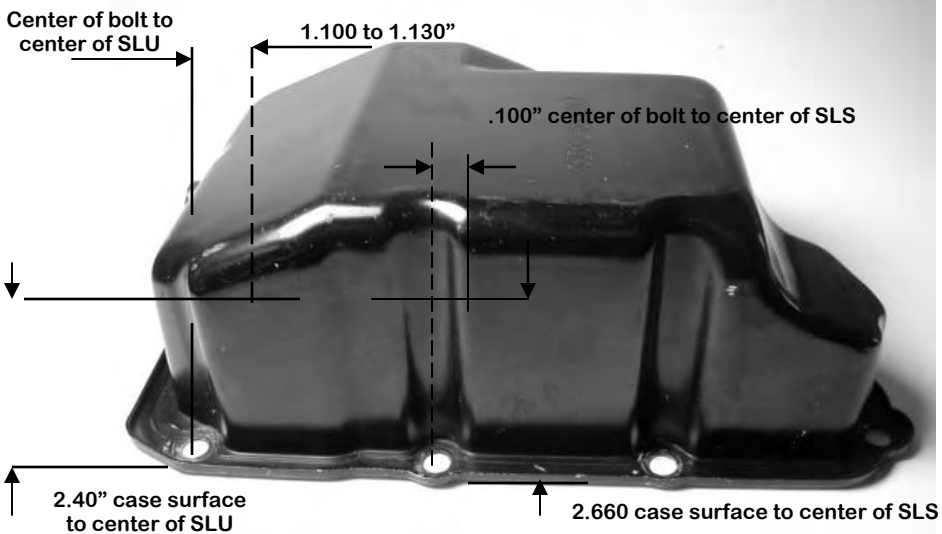
SL Solenoid Access

The side cover can be drilled and plugged to adjust the linear solenoids. Cover must be removed for this procedure!

Hole size depends on what plug you use. 1/4" blind head rivets are an option. Seal with silicone upon install.

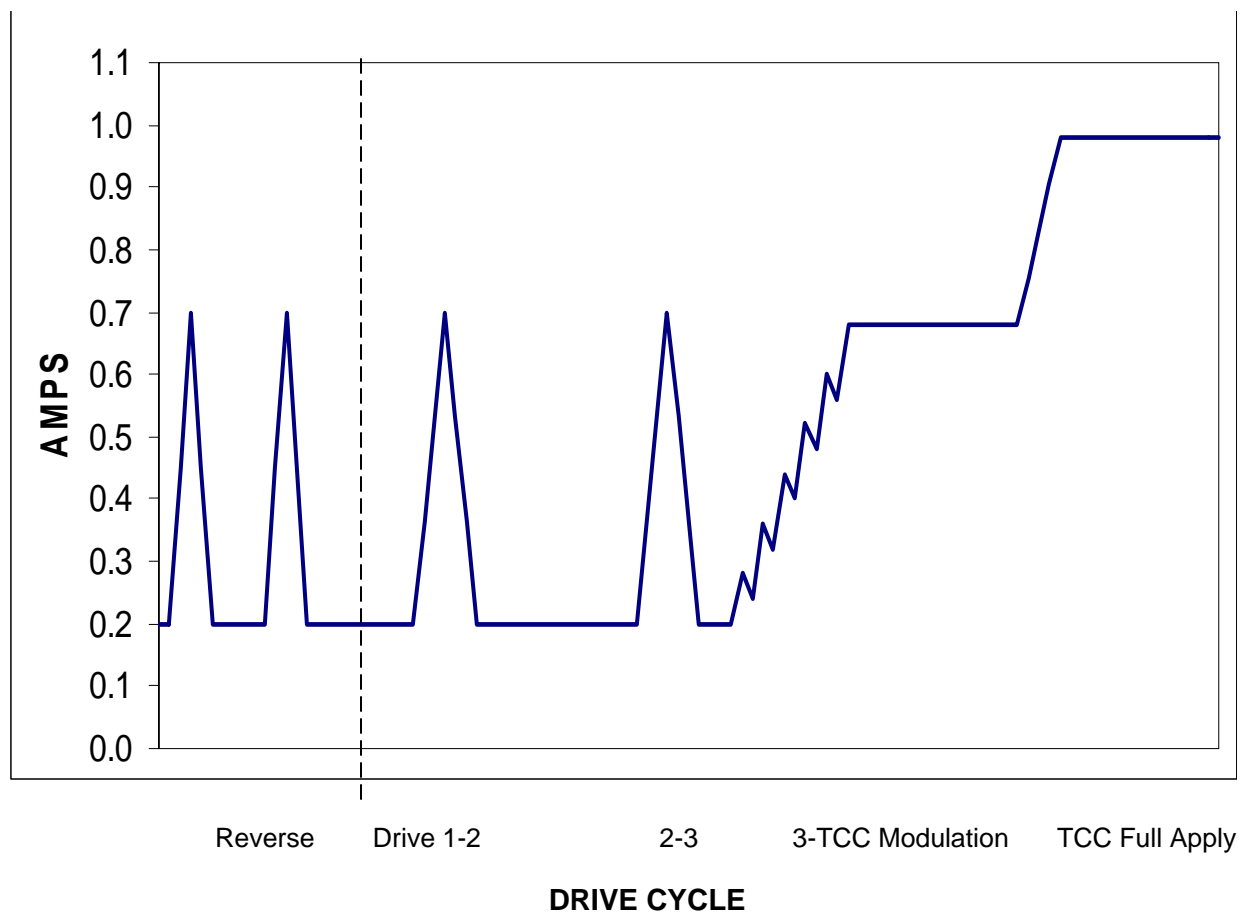
SLU SOLENOID

High current causes high pressure

Solenoid is Normally closed (N.C.)

300 Hz operating frequency 15%-48% duty 1 AMP, TCC is off.

SLU controls 2nd clutch (B-2) and low reverse (B-3). Manual low for engine, braking

SLU— Has been know to create 1-2 slip, 2-1 harsh downshift if not adjusted or defective. It also can over heat fluid and affect TCC apply.

SLU generally controls TCC right after 2-3, and will maintain TCC apply coasting or cruise at 25 mph.

Chart Example: '03 Volvo V70 XC

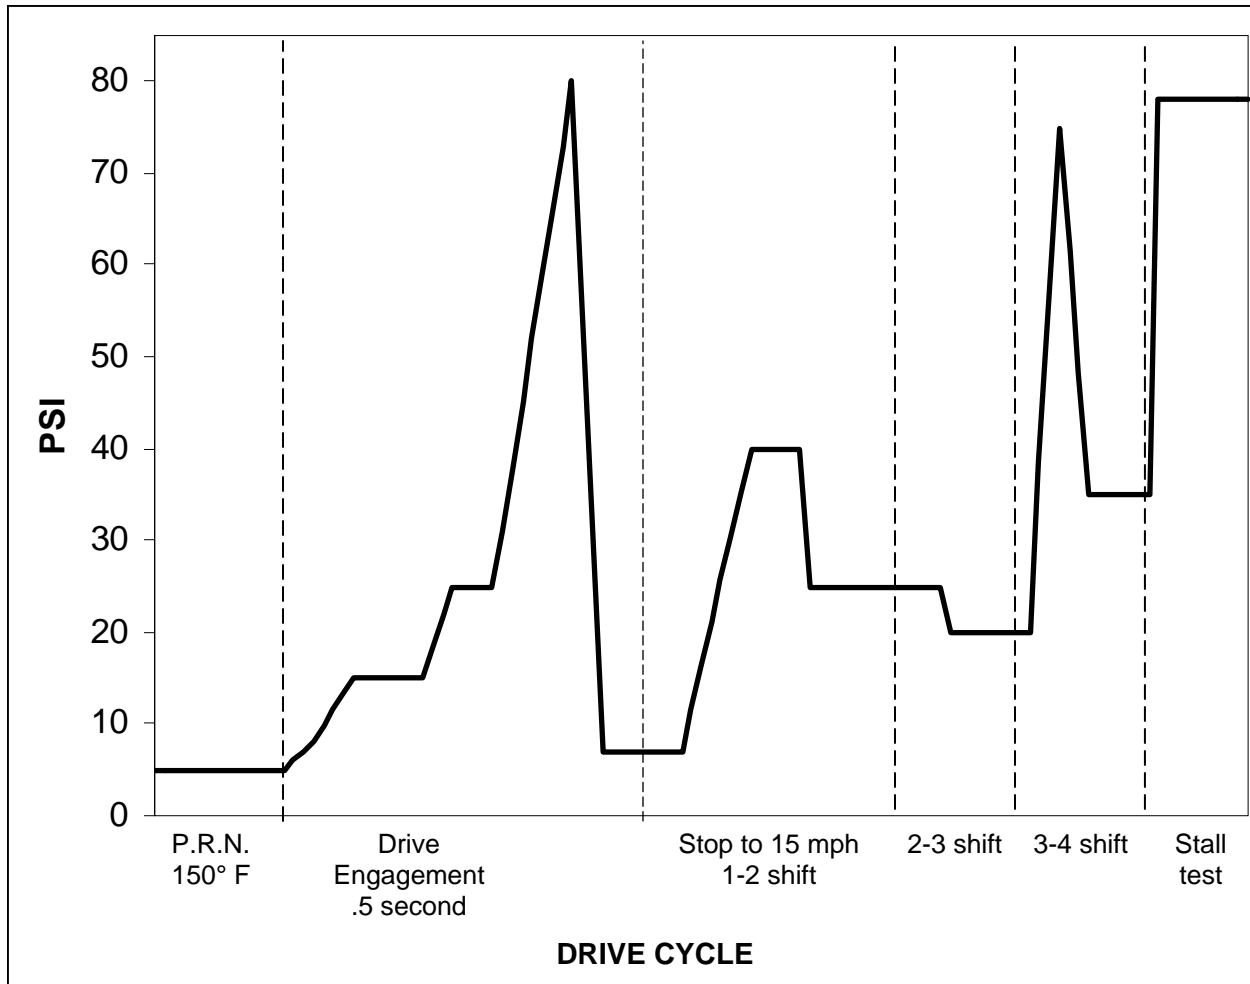
SLT SOLENOID

300 Hz operating frequency 15%-48% duty
 SLT is normally open solenoid (N.O.)
 Low current causes higher pressure (inverse proportional)

Chart Example: '03 Volvo XC 70 Vehicle data

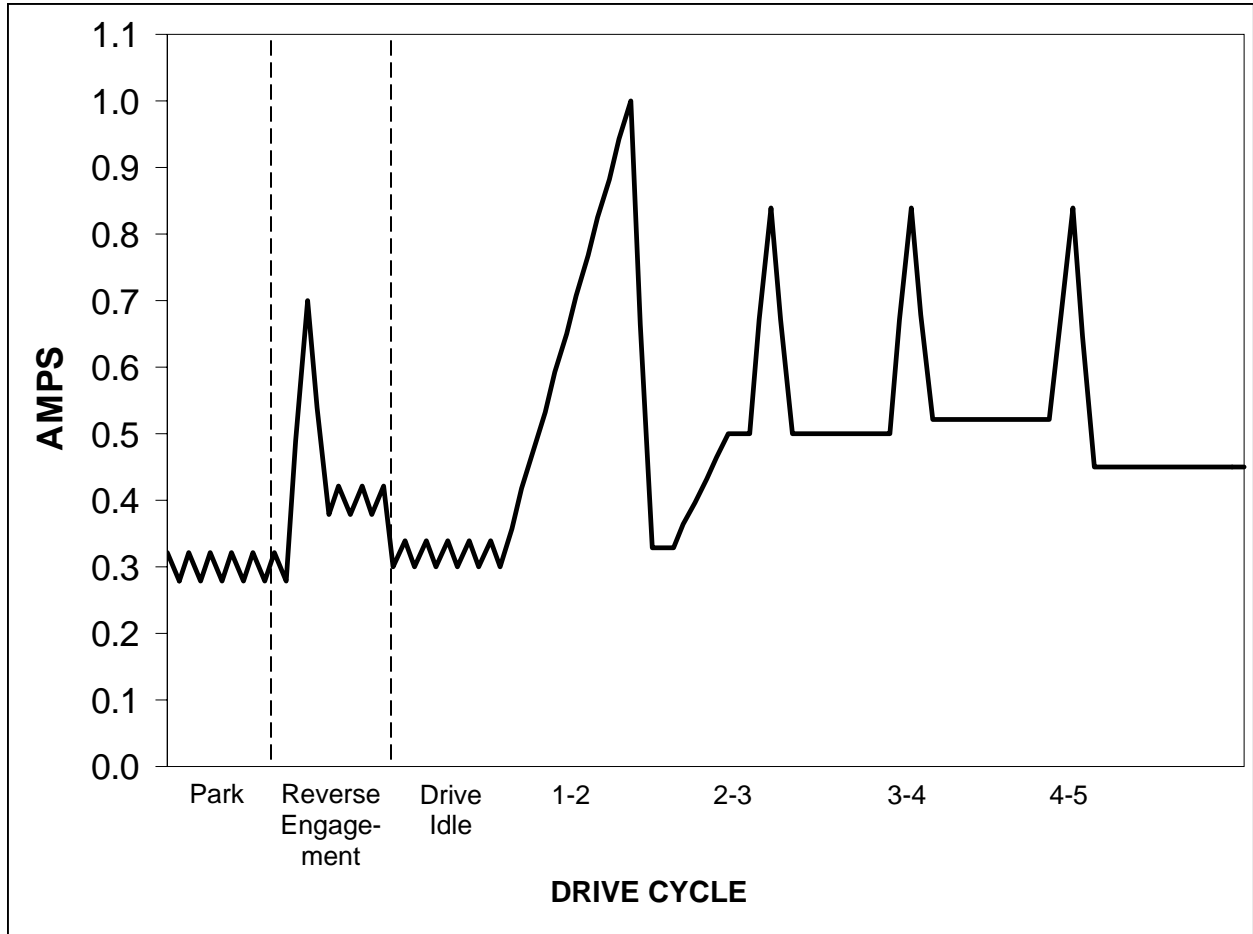
SLS SOLENOID

300 Hz operating frequency @ 15-40% duty

SLS is normally open solenoid (N.O.)

Low current causes higher pressure (inverse proportional)

This solenoid is spiked to increase clutch feed, then modulated between shifts.

Coast down shifts are modulated also with a pressure rise after each shift.

SLS controls: 2nd, 3rd, 4th, B-1 brake, 5th, Reverse, C-2 clutch

Chart Example: '03 Volvo V70 XC

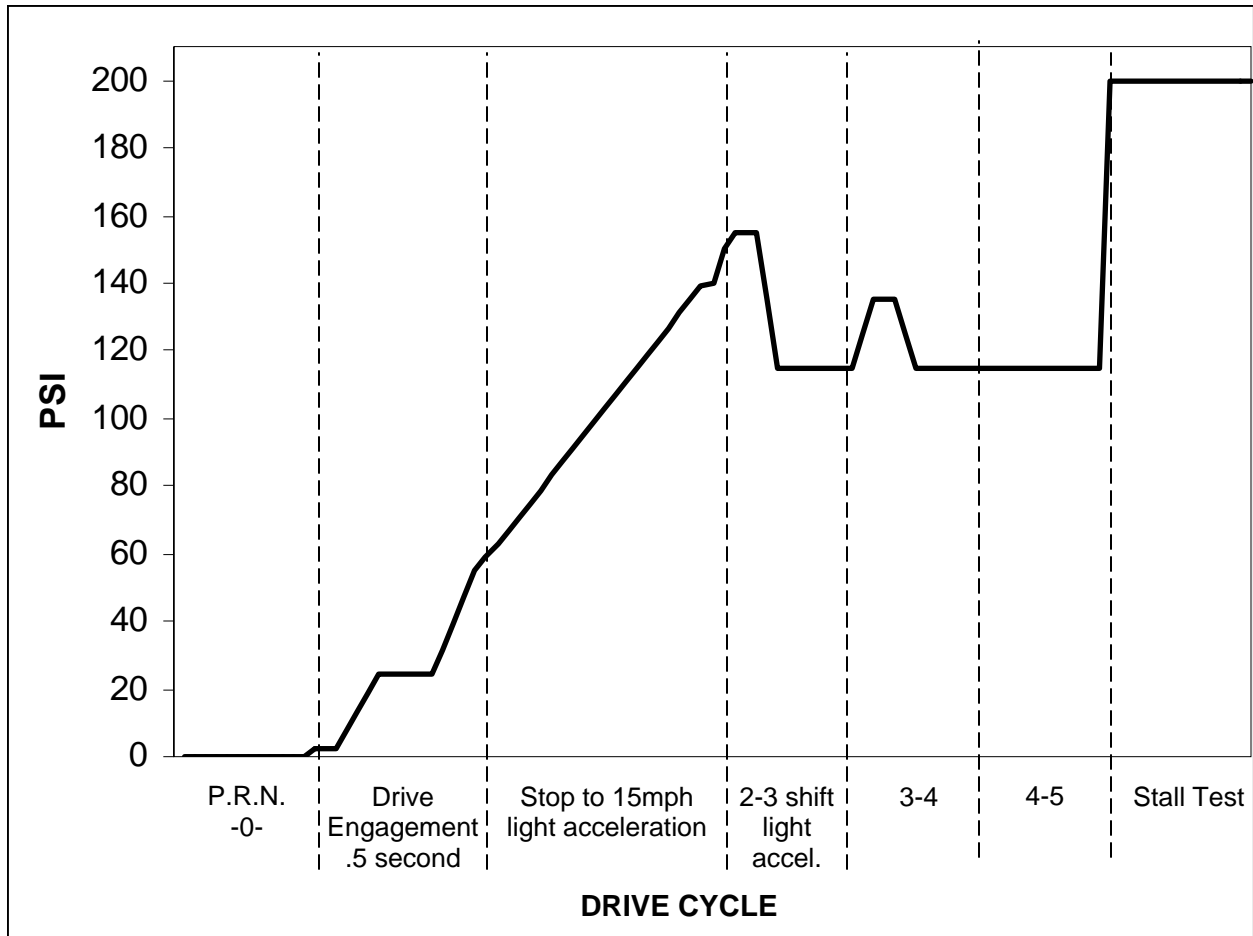
C-1 CLUTCH PRESSURE

Note: If C-1 pressure upon initial engagement is 160 instead of the 50-60 psi, the TCM has commanded a pressure rise. Verify with SLT amperage, then check for codes and electrical issues.

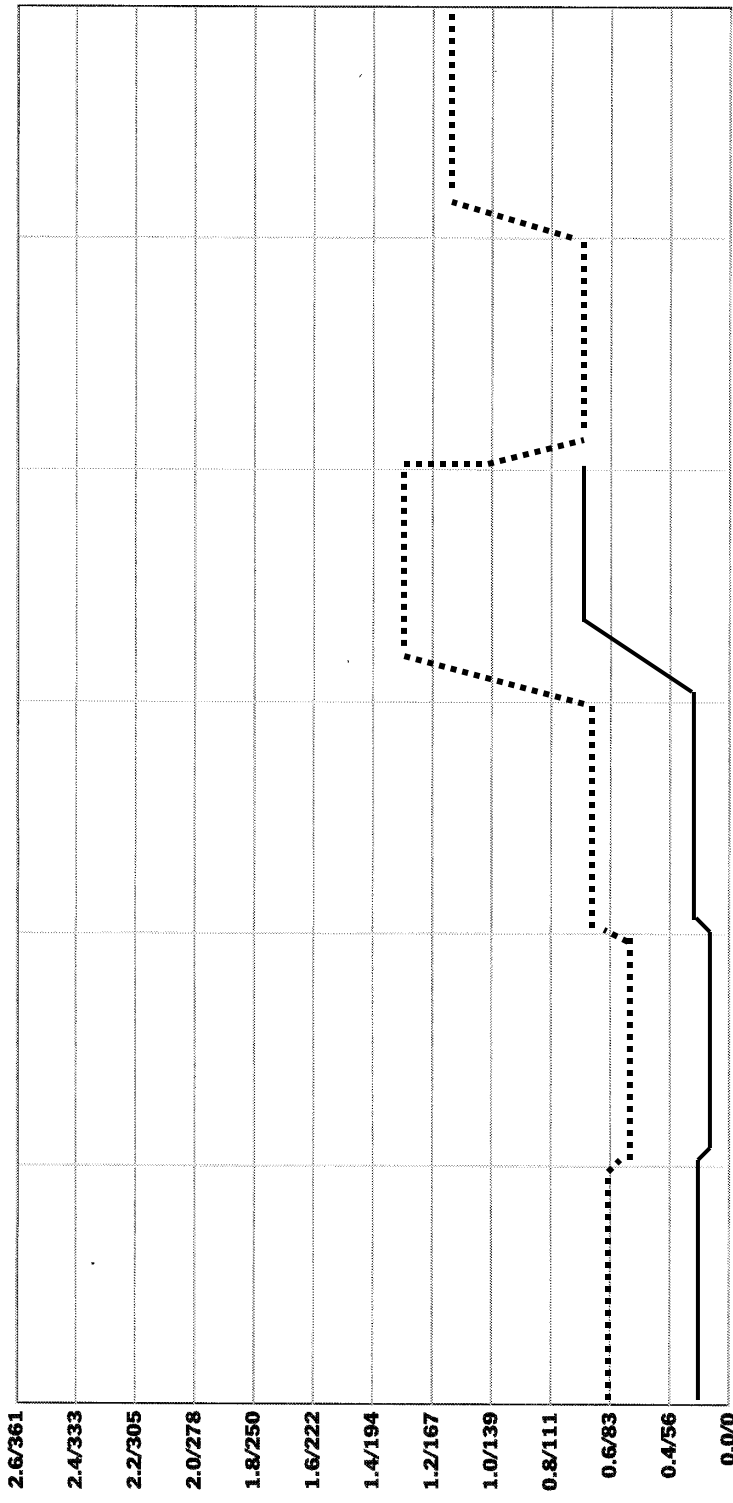
GPM/HZ

Event: Normal conditions

Condition: Cooler flow 8°F Cooler flow 8°F Cooler flow 150°F

Lube pressure: 8°F 12 psi P 150°F 9.0 psi P
 OEM: 8°F 34 psi Revs. 150°F 9.2 psi Revs.
 Cooler lines: 8°F 24 psi Drive 150°F 6.0 psi Drive

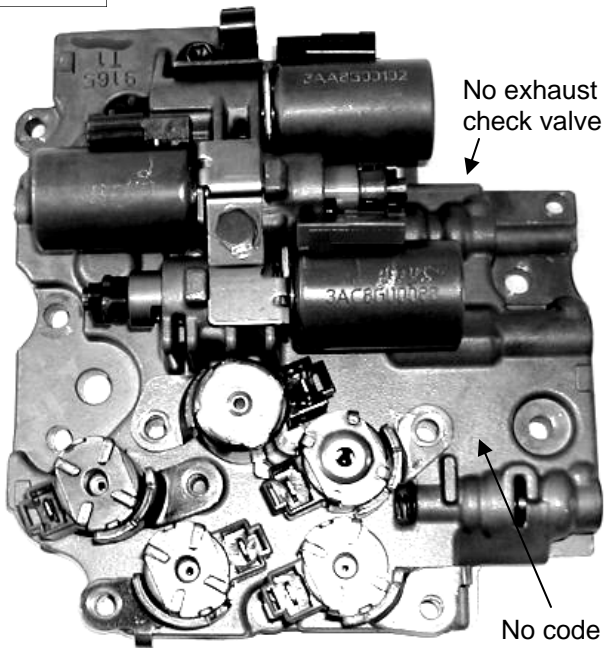
Fig. 1

This casting does not match the GM AF-23 oil circuits in Blue Technicians guide.

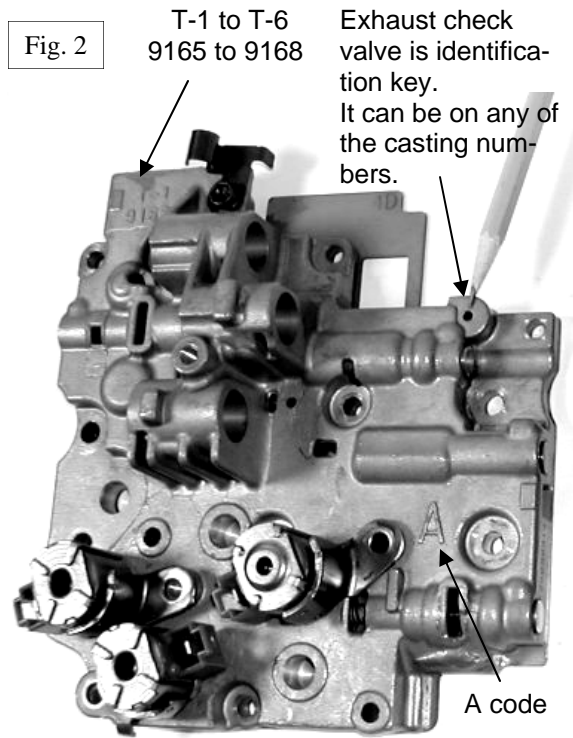
Fig. 2

Code: No = Early
C is late

Typical of the updated Volvo, C valve body

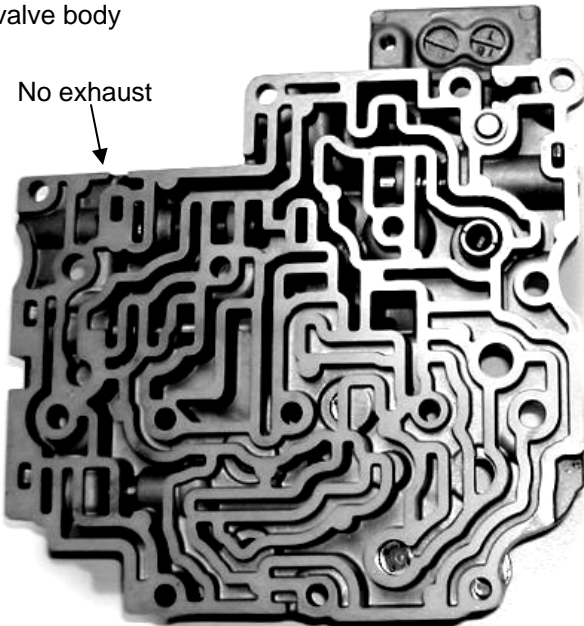
Fig. 1

No exhaust

Exhaust Casting matches GM AF-23 Technicians guide oil circuits.

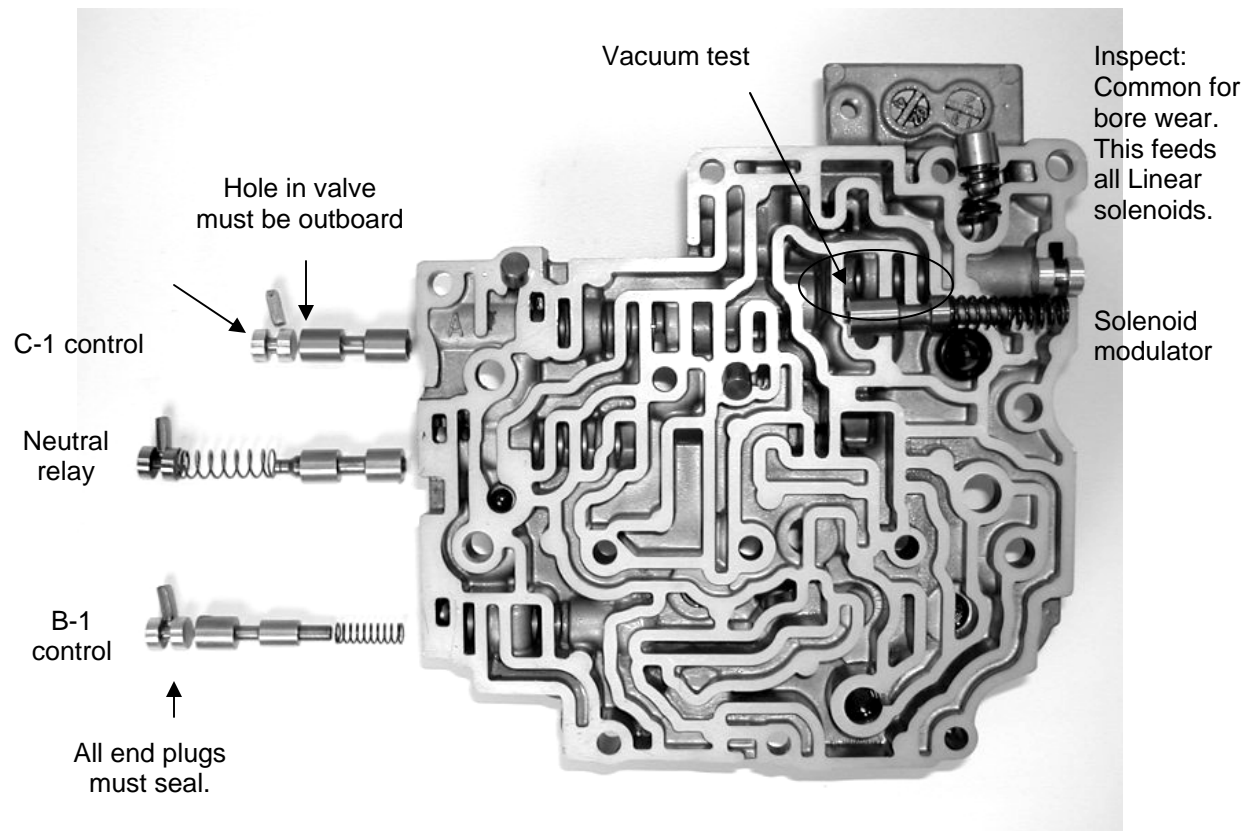
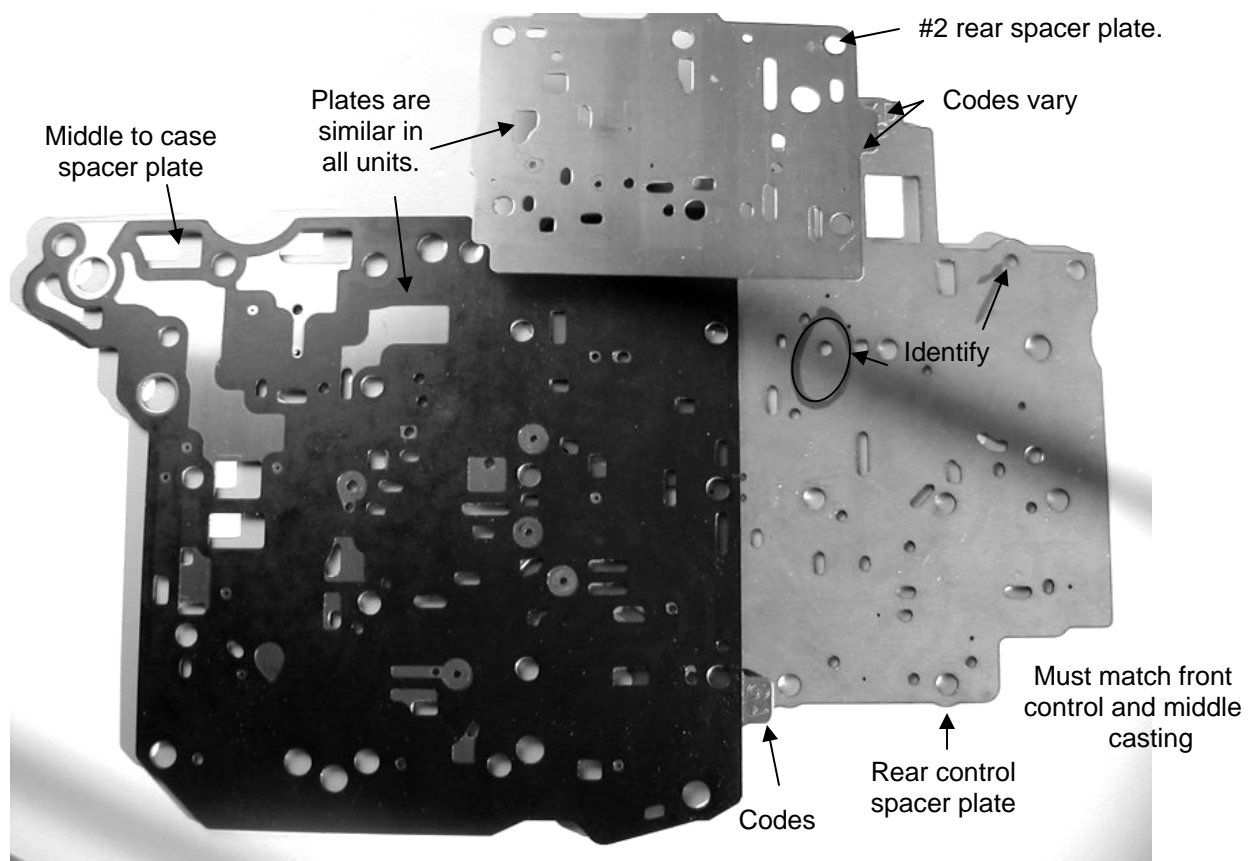
MID-CASTING:
Cover Side

- Inspect for visible wear & scoring.
- Vacuum Test, minimum of 18" vacuum.

Vacuum test for
pressure
regulator valve
bore wear.

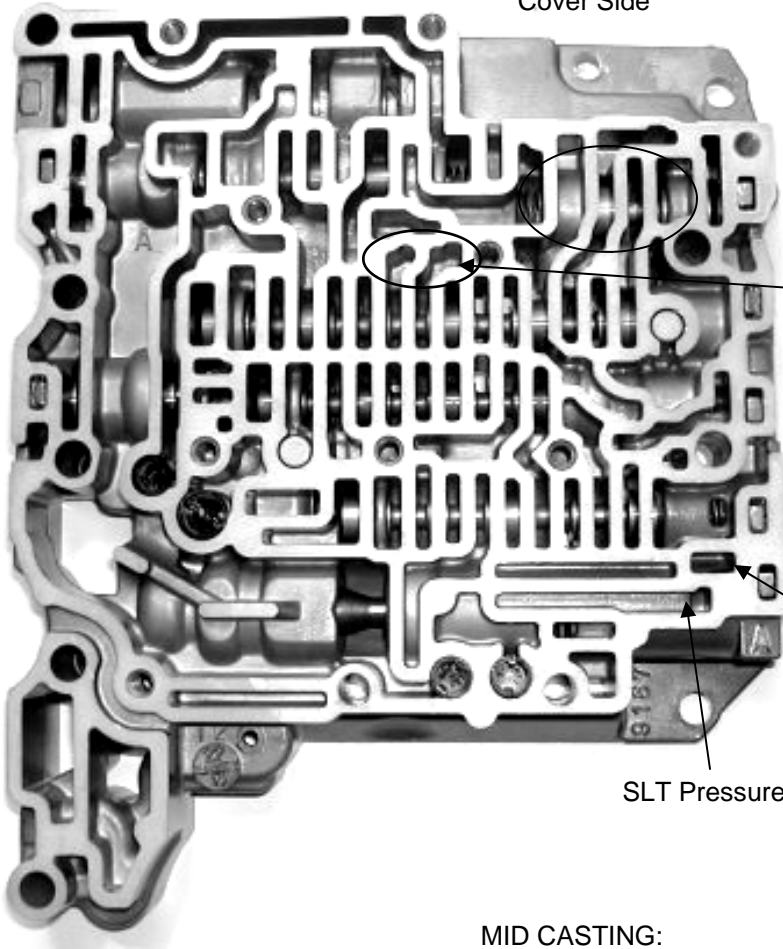
This casting (two flags):
Must go with exhaust type
plate and front control.

*One flag on right only:
Assembles with a non-exhaust
plate & front control.

Boost sleeve vacuum test

SLT Pressure

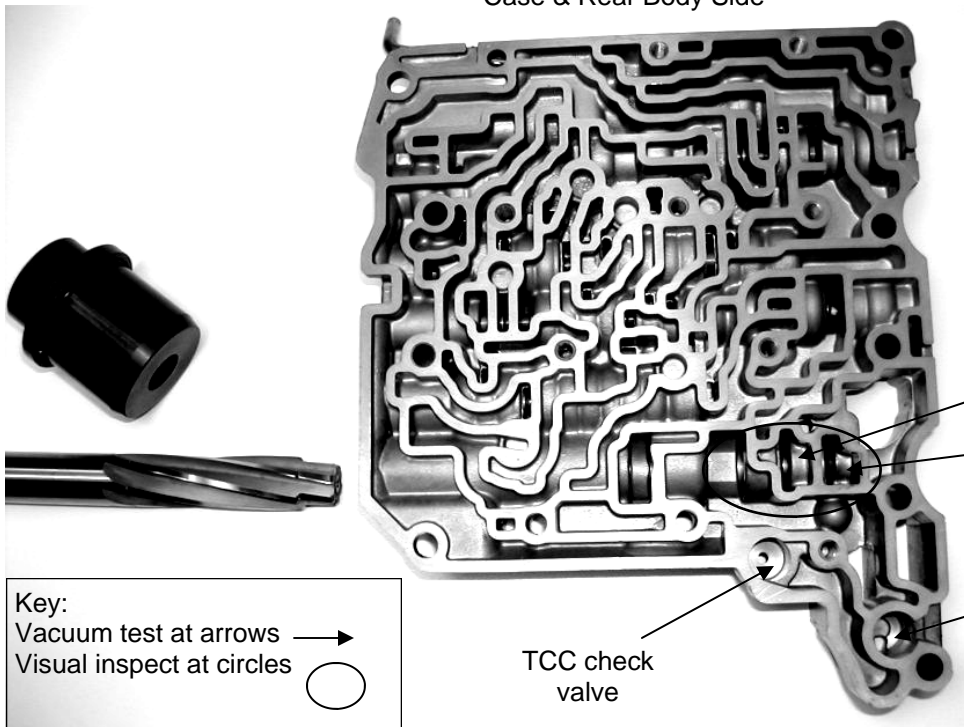
MID CASTING:
Case & Rear Body Side

Cooler bypass.

TCC check
valve

Key:
Vacuum test at arrows →
Visual inspect at circles ○

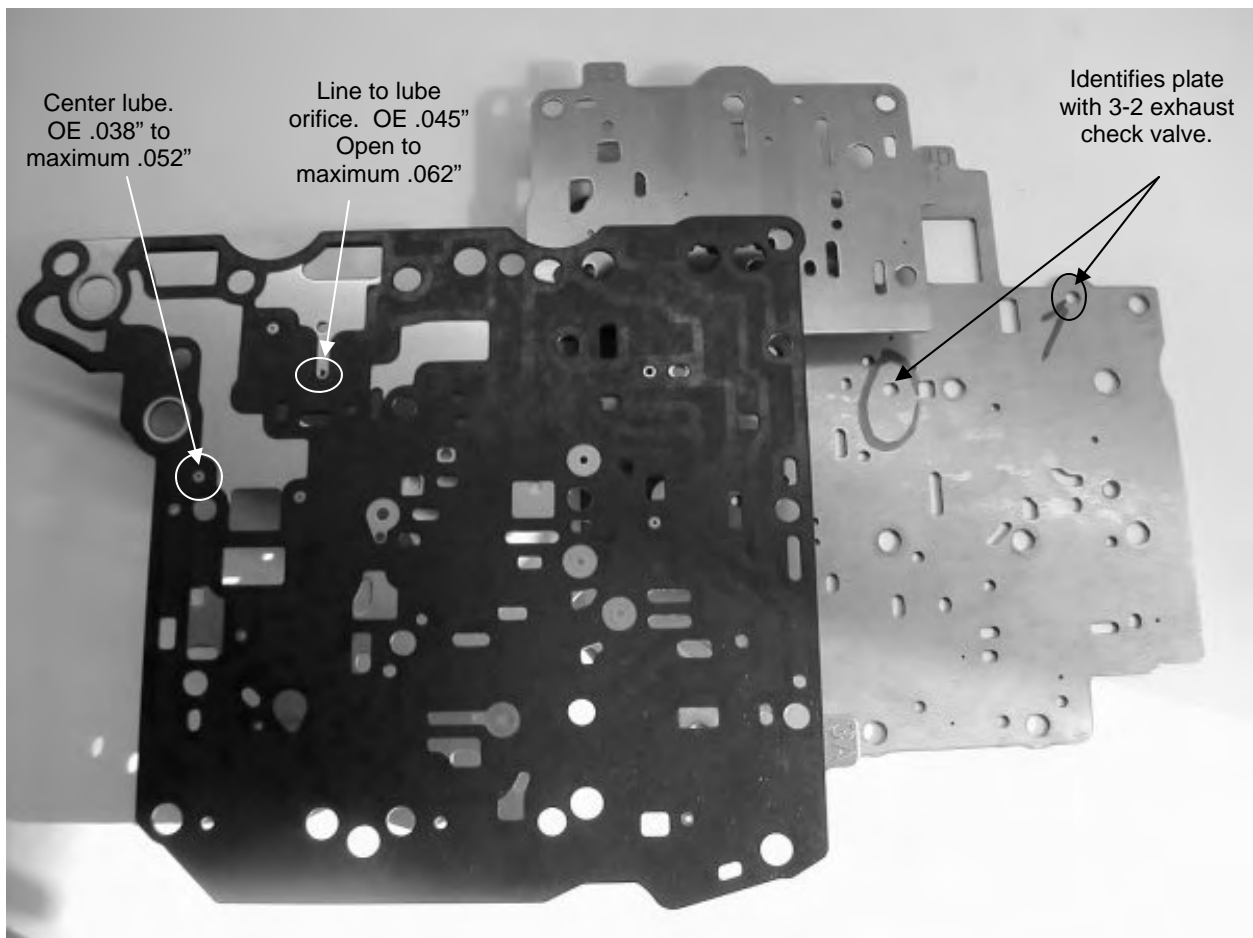
Separator Plates

Plates must match the top & middle casting

A separator plate modification can be performed, if the secondary regulator bore has minimal wear. This modification will increase lube and converter feed oil flow. Enlarging the plate feed holes is not suggested if the valve body casting has excessive wear at the secondary regulator bore, in the area of the spring to spool surface.

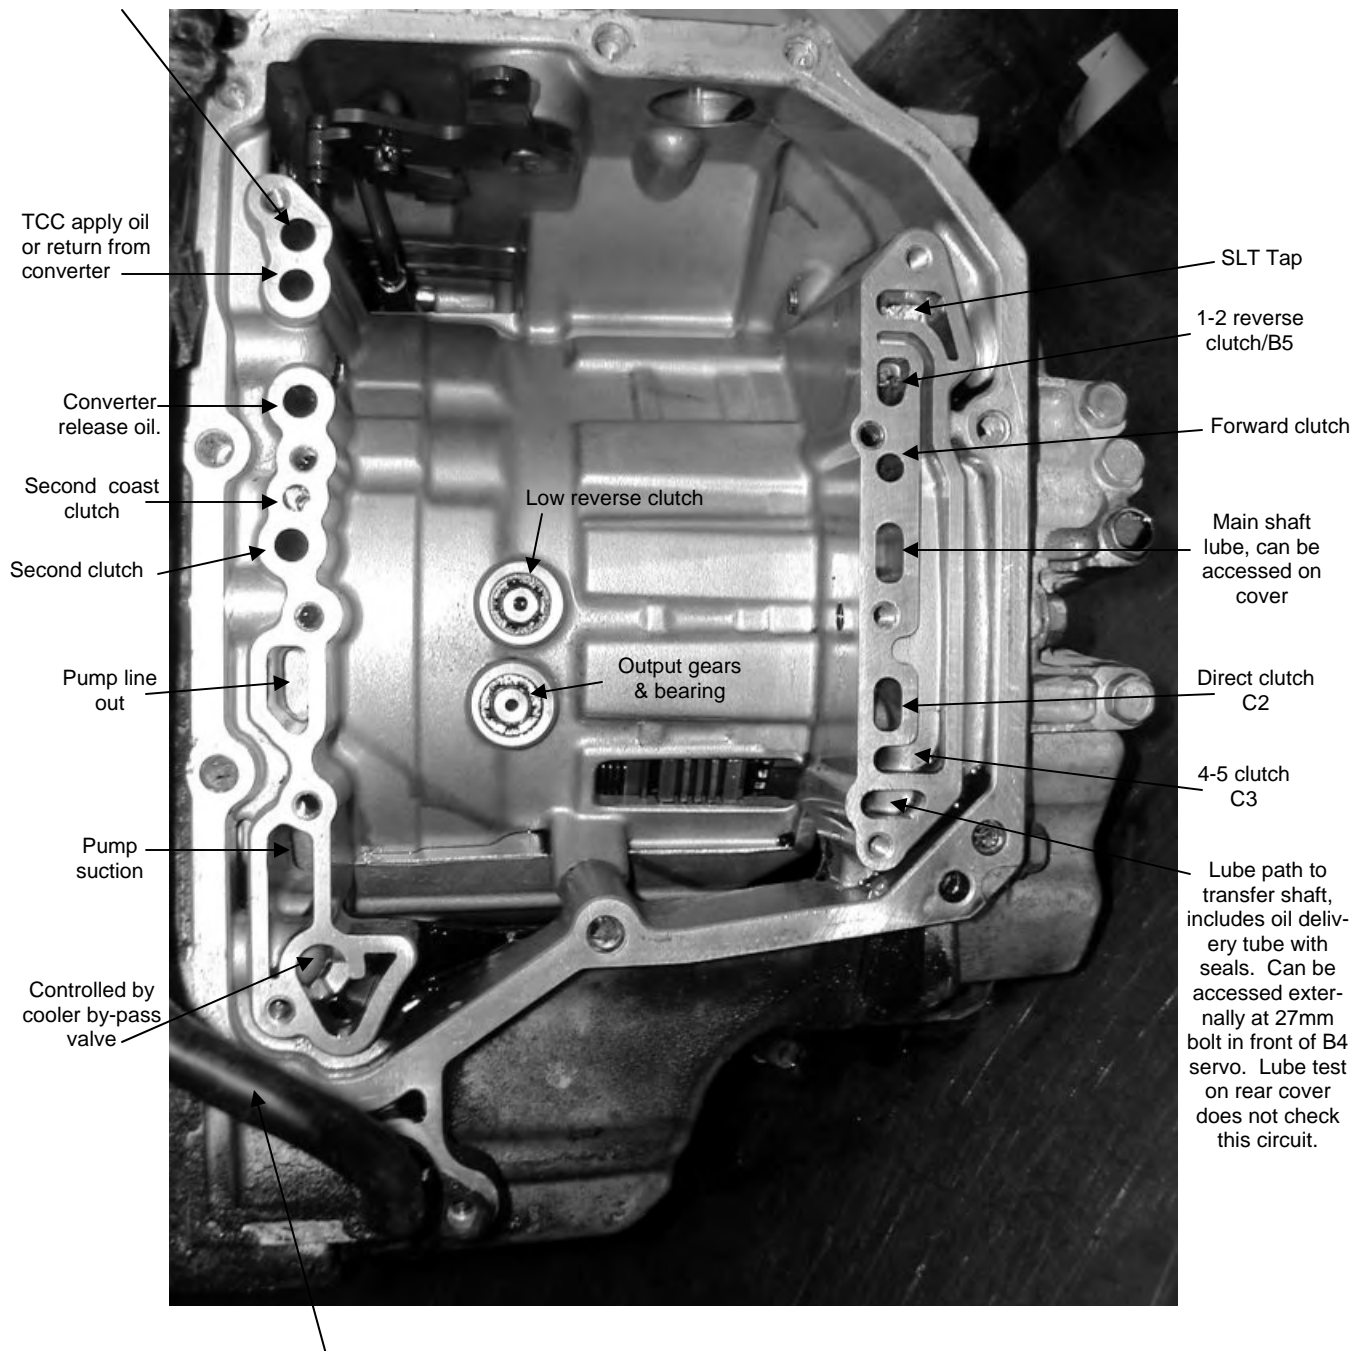
Volvo pictured
Converter out line to cooler. Cooler returns into valve body cover.

AF 23/33
Left side is converter out, right is return to sump.
